Baseline Assessment

Greenough Land

November 2008

**Prepared by the
Land Stewardship Committee**

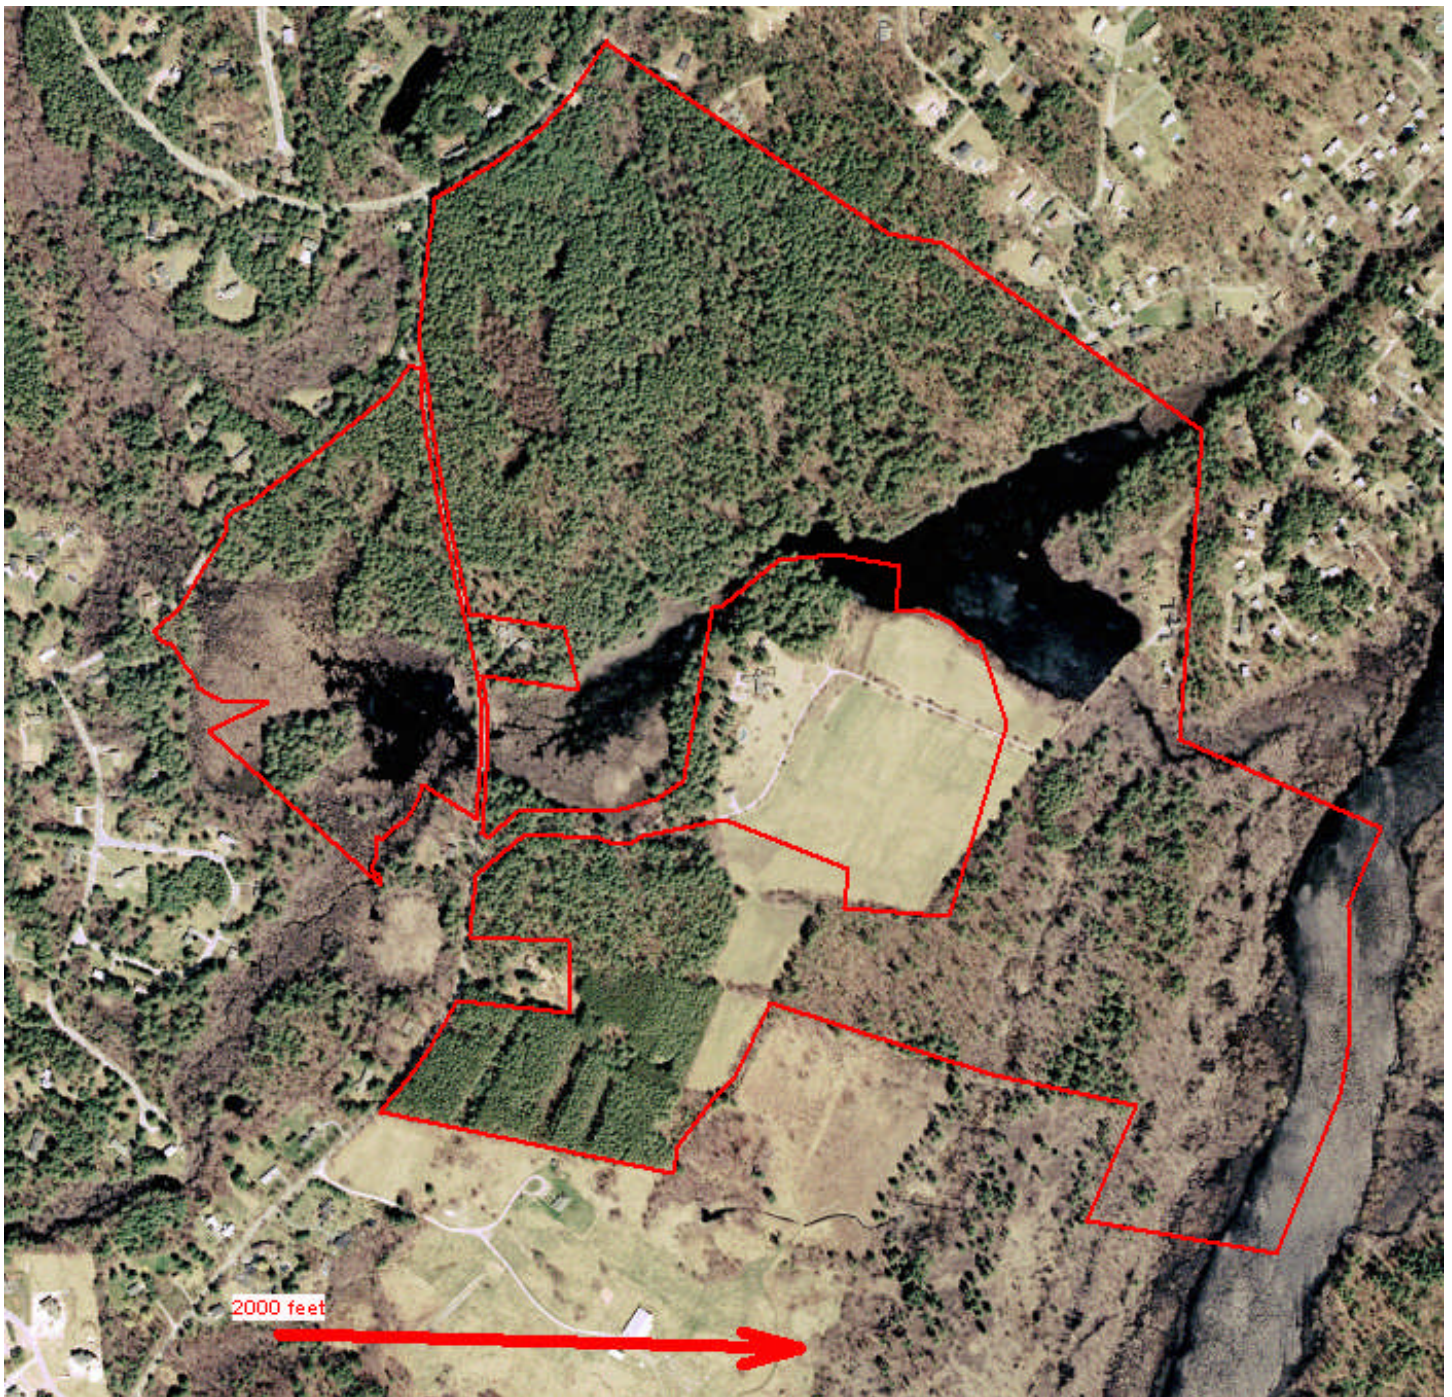
Figure 1-5. Aerial Photo of Greenough Land

Notes: 1) Property boundary shown in red. Boundary line locations shown are approximate.
2) Red arrow (for scale) is 2000 feet long.
3) Photo date: 2001 (published in 2005).

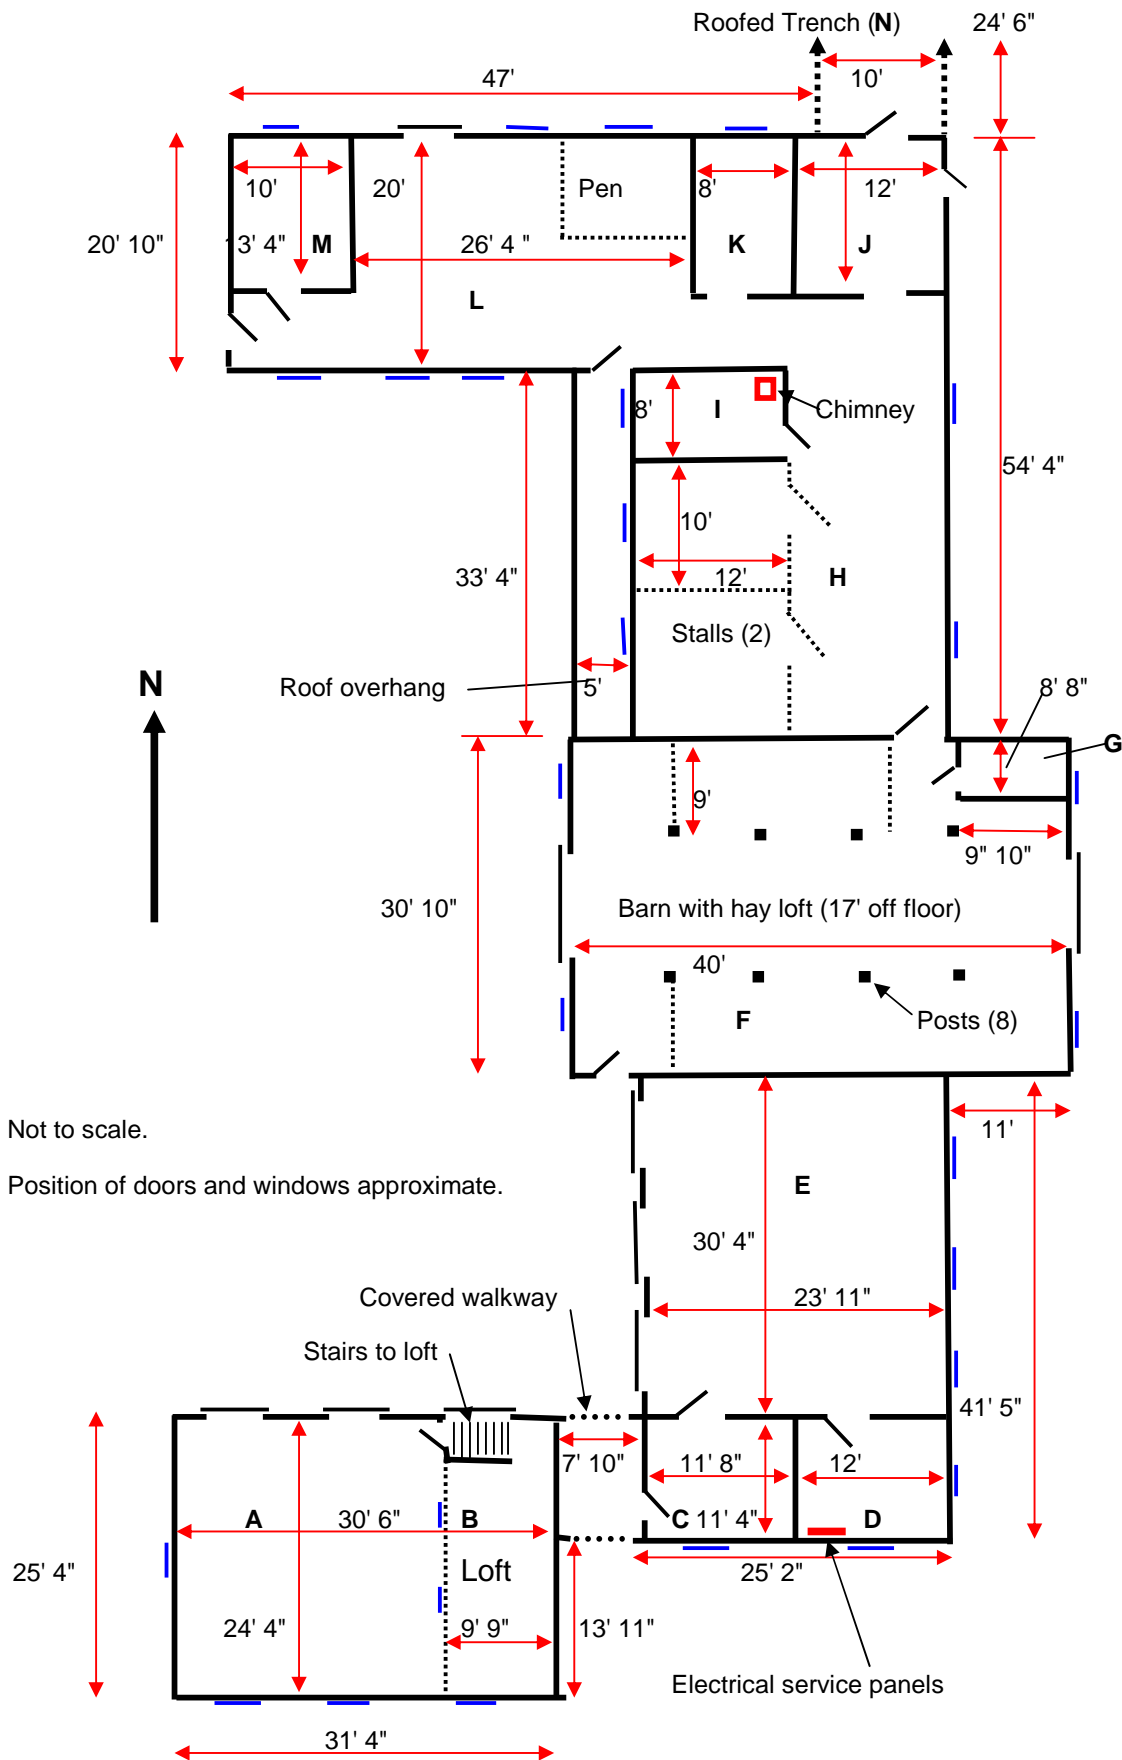
Figure 1-9. Schematic of Greenough Barn Ground Floor Plan

The Greenough barn is quite large, extending over 140 feet in the north-south direction (not including a 25-foot covered trench for manure collection) and over 75 feet in the east-west direction. Excluding an attic over part of the north end of the barn, the building has 13 interior rooms, some subdivided by partitions or fences into animal stalls or storage areas. The flooring in almost all areas is cement. A schematic diagram of the Greenough Barn floor plan is given in **Figure 1-9**; individual rooms are designated by letters (A-N). In the large barn-like room in the center of the building (room F), there is a hay loft (~ 17 feet up) in the central part of the room (between the posts); from the floor to the roof peak is ~ 34 feet. Portions of the floor on the sides of the room, including room G, are raised (wood). An overhead trolley track is in rooms H, L and J, and was likely used to transport manure to the covered trench area (room N). Room K contains feed bins along the east wall. Other rooms contain storage cabinets, shelves and workbenches (rooms A, C & H), or furniture (room B: loft). As of an inspection on May 31, 2007, there were still a substantial number of junk items which need to be removed from the building. Figure 1-6 does not show the full extent of the 10-foot wide roofed trench (room N) which extends 24 ½ feet from the north end of the barn. The bottom of the trench is about 2 ½ feet below grade. At the end of the trench, a 10-foot ramp leads to grade. Near the north-west corner of the covered trench is a circular cement cover (~ 3 feet diameter) which may cover a cistern.

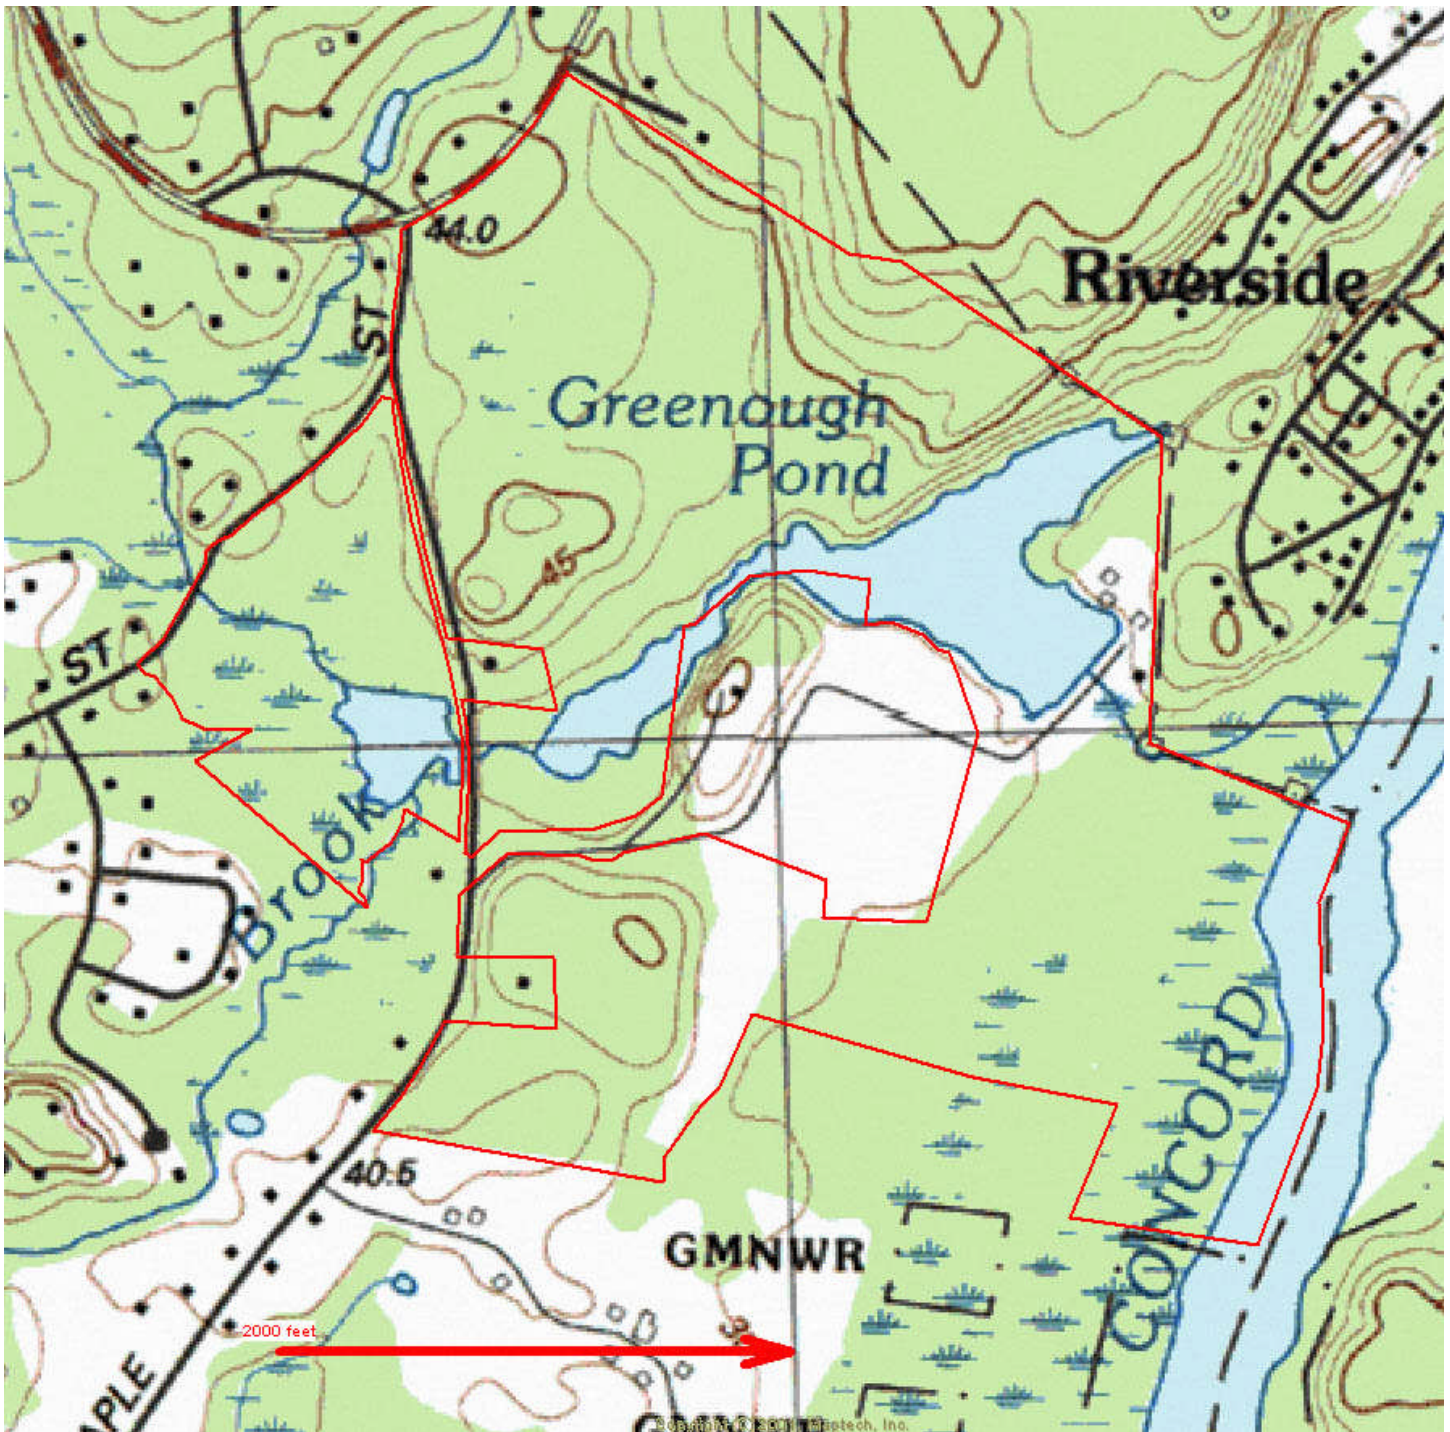
Figure 1-10. Greenough Land Topography

- Notes:
- 1) Property boundary shown in red. Boundary line locations shown are approximate.
 - 2) Black dashed line is Town boundary with Billerica.
 - 3) Elevations in meters. Contour intervals are 5 meters.
 - 4) Red arrow (for scale) is 2,000 feet long.
 - 5) Topo base map date: 1987.

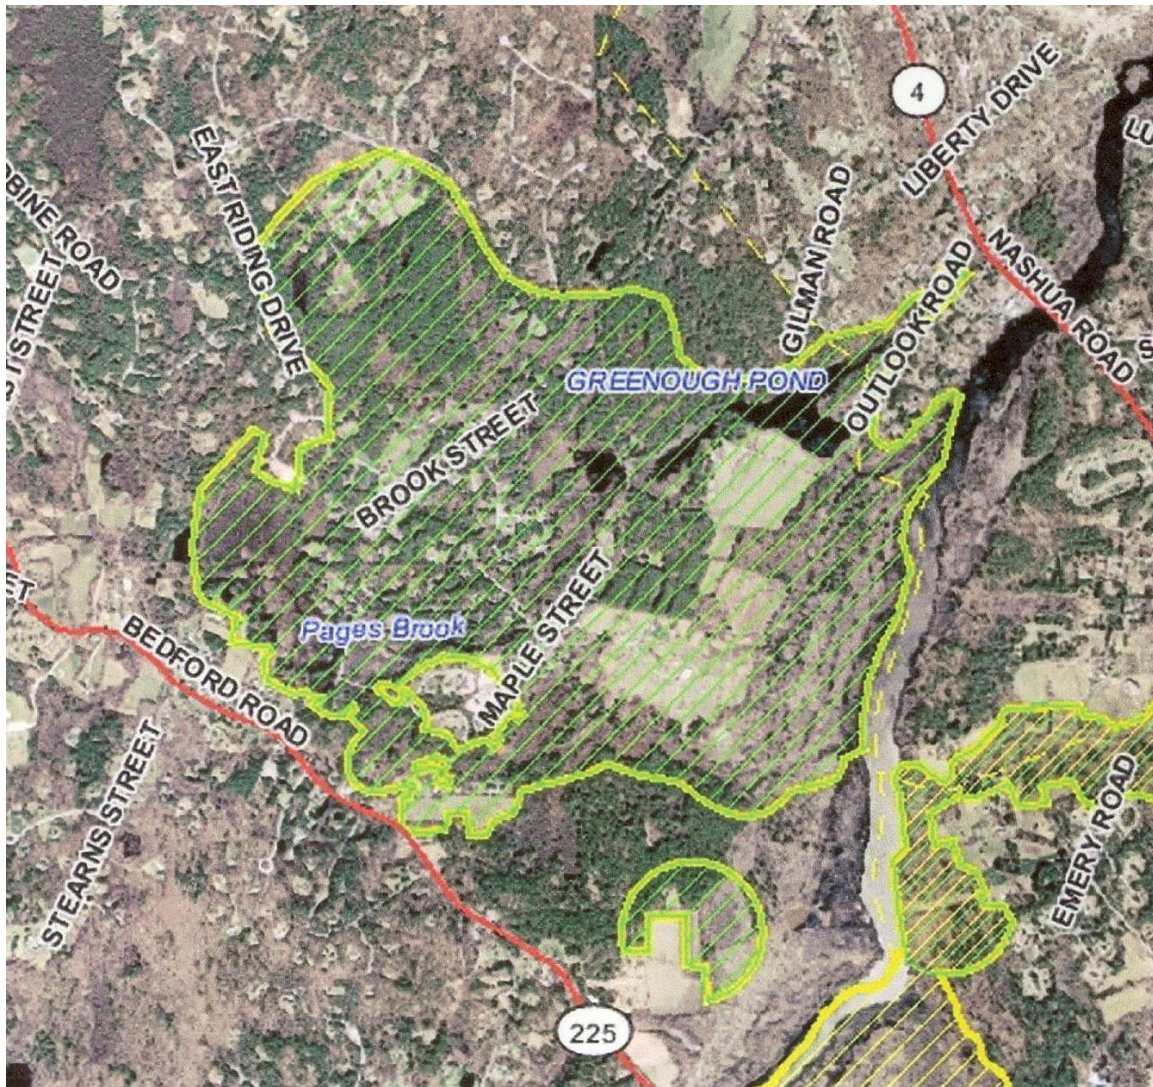
Figure 4-2. NHESP's Priority Habitat Area Near the Greenough Land

The green hatched area (yellow border) in the center of figure is part of NHESP's 2008 Priority Habitat of Rare Species and also Estimated Habitats of Rare Wildlife. The Greenough Land is approximately centered on Greenough Pond. This NHESP figure was issued October 1, 2008.

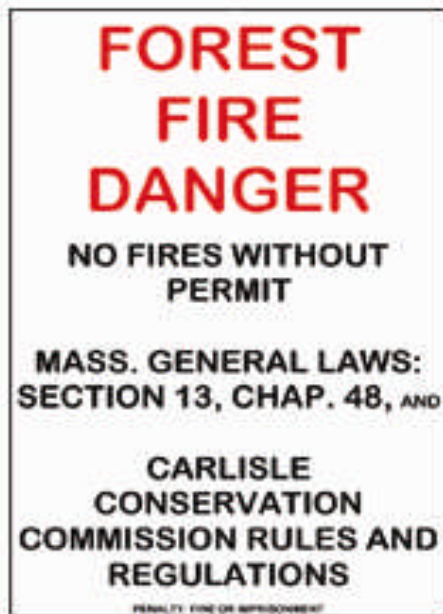
Figure 5-1. Sign Placed at Location of Illegal Fire Pit

A sign has been erected in the middle of the dirt road near the southwestern end of the Greenough Pond dam stating that no motor vehicles are allowed. (See photo in Appendix F.) In late 2007, after an illegal fire pit was found on the north shore of Greenough Pond, a special warning sign (laminated paper) was placed at the site, and a standard conservation sign listing allowed and prohibited uses (laminated paper) was placed on the nearby trail visible to hikers coming from Billerica.

In November 2007, the Land Stewardship Committee recommended to the Conservation Commission that the old cart path leading from the intersection of Brook and Maple Streets eastward to Greenough Pond (and extending almost to the Billerica Border) be brush cut to allow emergency vehicles to access the area of the illegal fire pit recently found. This action had been recommended by the State’s District Fire Warden who had

visited the site. A recommendation was also made to replace the large rocks at the Maple Street trailhead with a locked gate. The actions are under consideration.
